Case 266 : Narrative

Case Vehicle (A): 2000 Ford
Type: Ranger Supercab XLT, 4x4 pickup
Driver: 17-year-old male
CDC: 12-FLEW-3, 00-RDAO-2

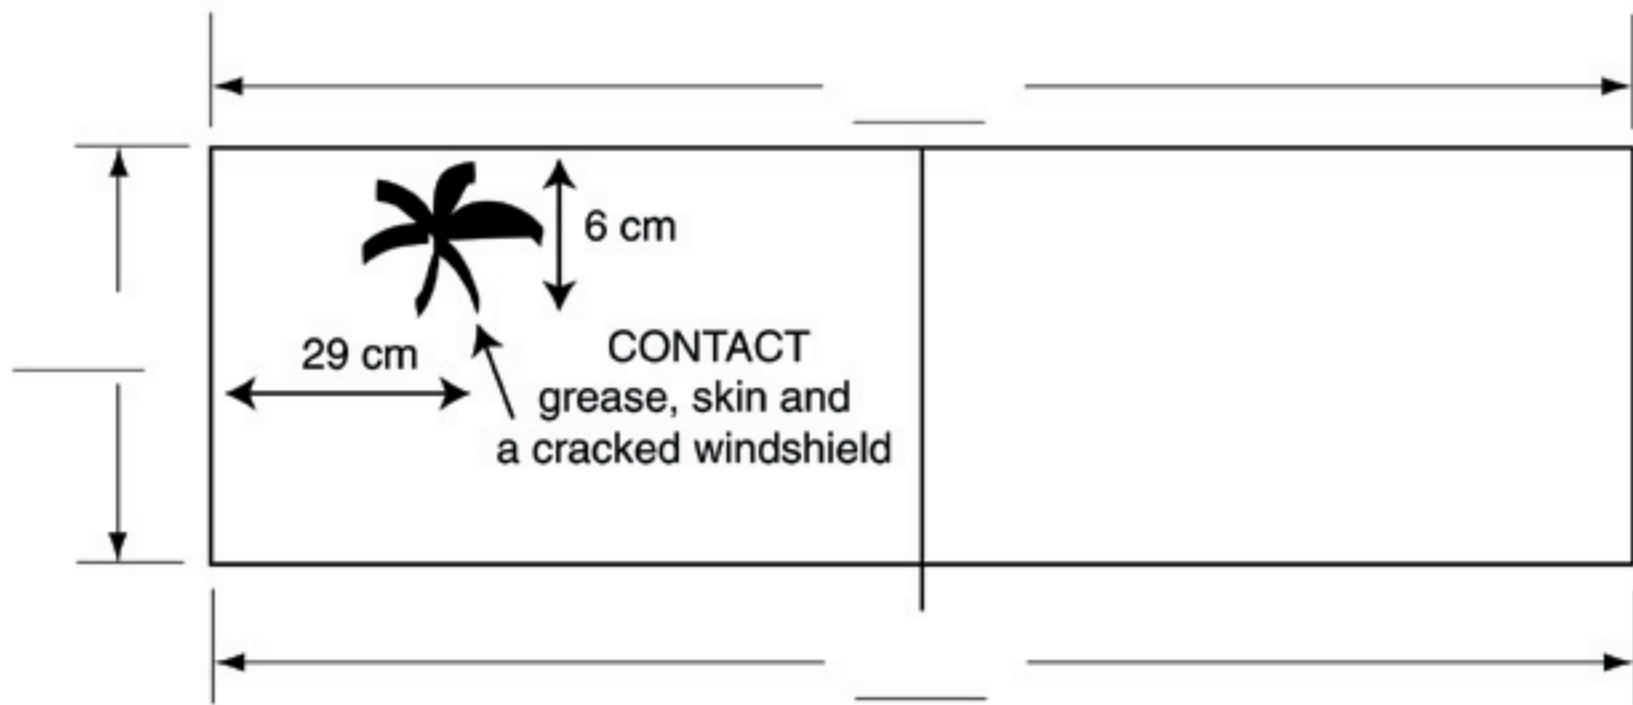
INTRUSION IT-1

A: windshield
(4-cm crack in glass, grease mark)

C: driver-side sunvisor
(3-cm scuff mark)
